A SUMMARY REPORT (1970 - 1971 - 1972) OF THE ABATEMENT OF ARSENIC  
CONTAMINATION IN THE MOIRA RIVER AT DELORO.

ONTARIO MINISTRY OF THE ENVIRONMENT. INDUSTRIAL WASTES BRANCH.  
JANUARY 1973.

INDUSTRIAL WASTES BRANCH

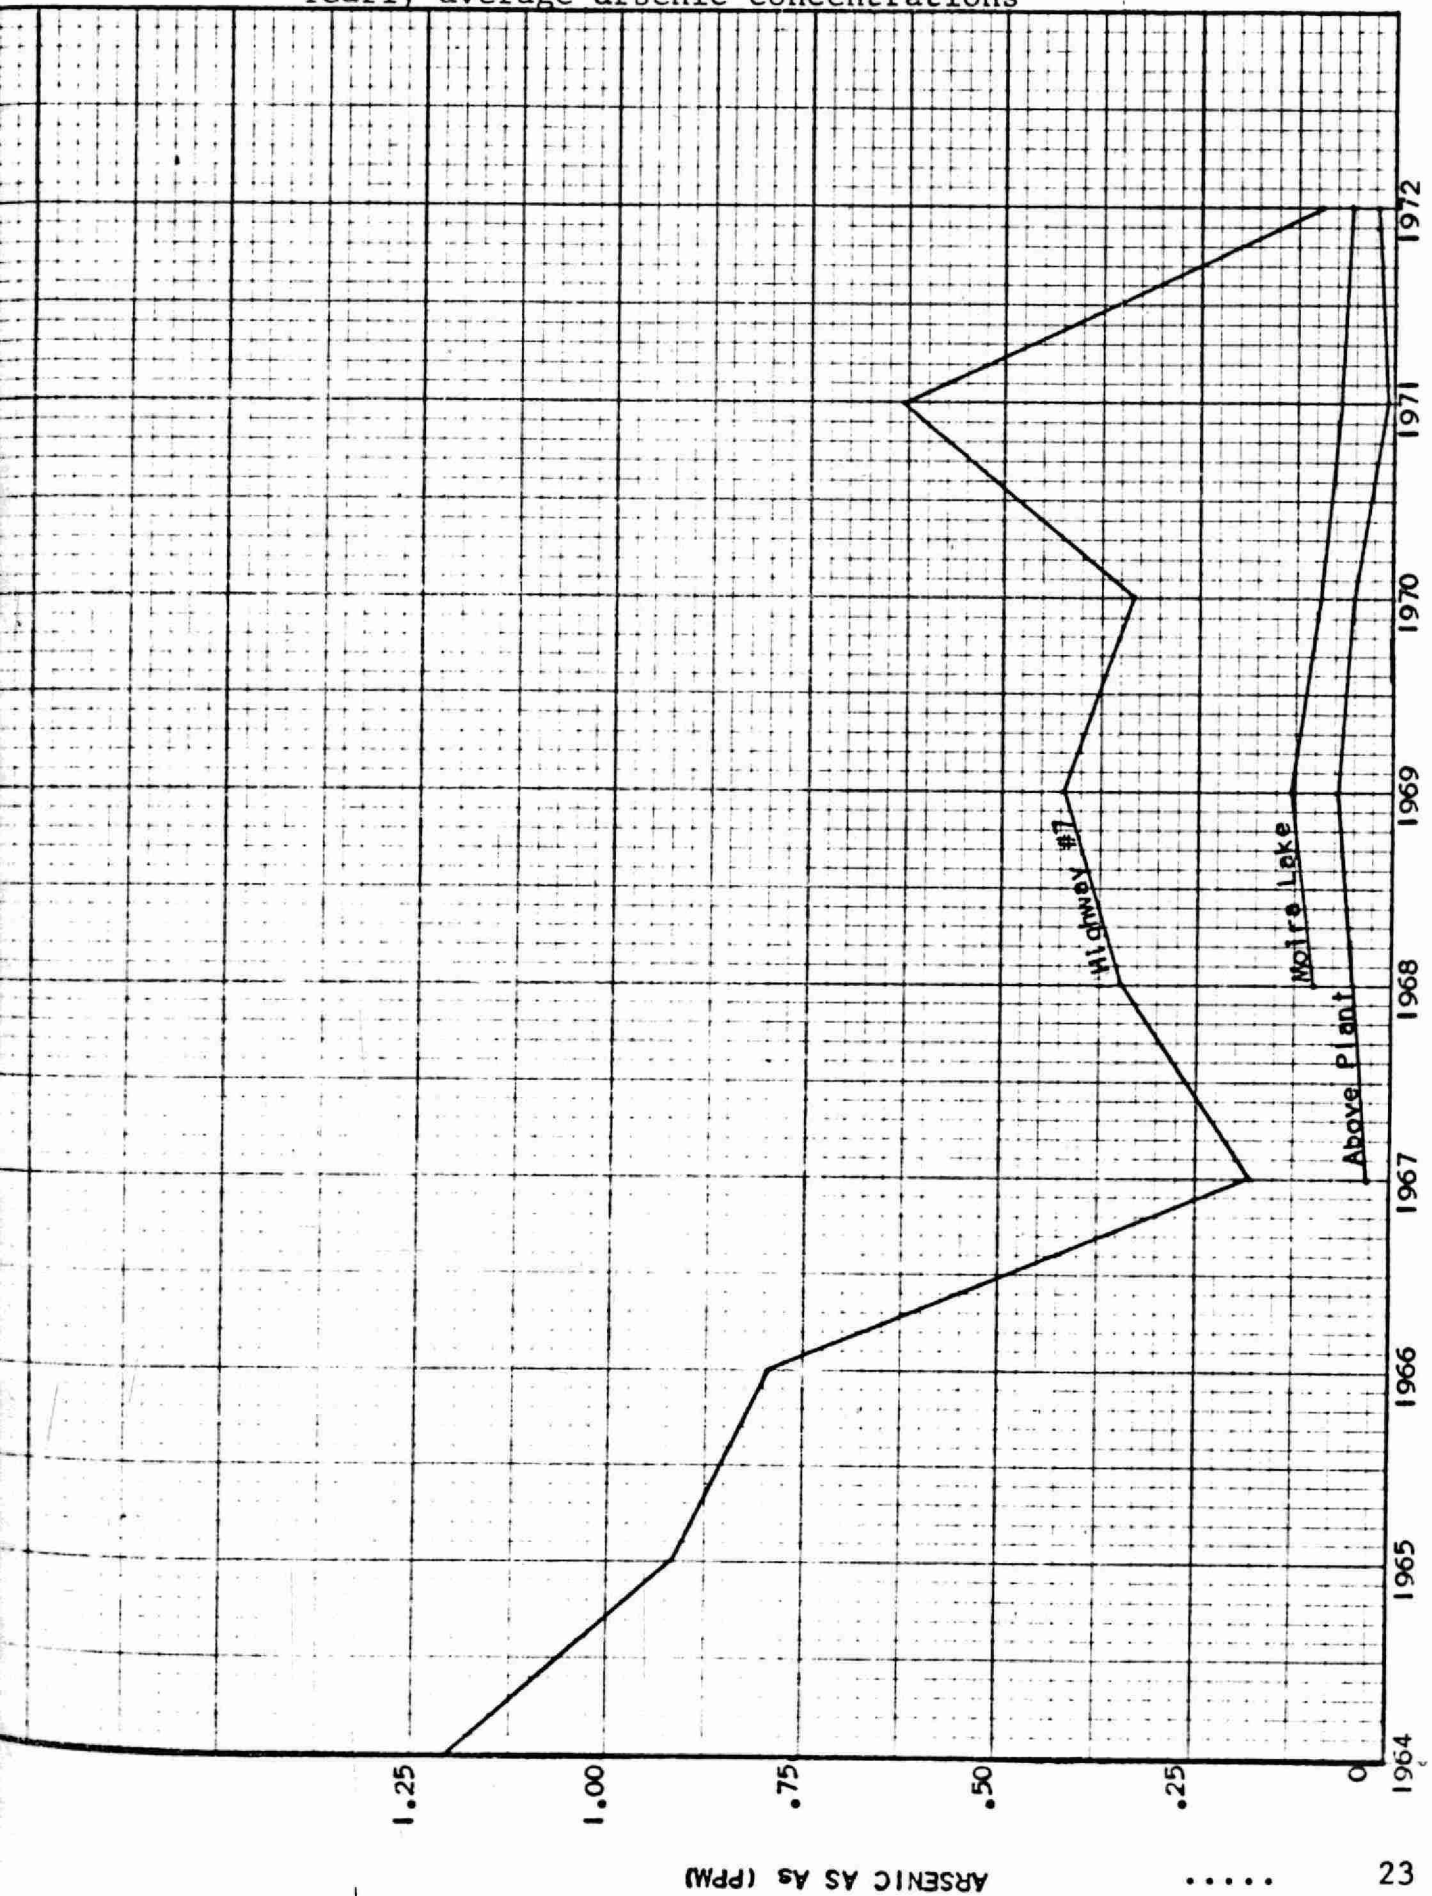
APPENDIX II  
Yearly average arsenic concentrations

In Appendix II, the yearly average arsenic concentrations above the plant site and at Highway #7 are shown graphically.
